A-10 STATIC STRUCTURAL TEST PROGRAM

TECHNICAL REPORT AFFDL-TR-79-3014

Final Technical Report

AIR FORCE FLIGHT DYNAMICS LABORATORY
AIR FORCE WRIGHT AERONAUTICAL LABORATORIES
AIR FORCE SYSTEMS COMMAND
WRIGHT-PATTERSON AIR FORCE BASE, OHIO 45433

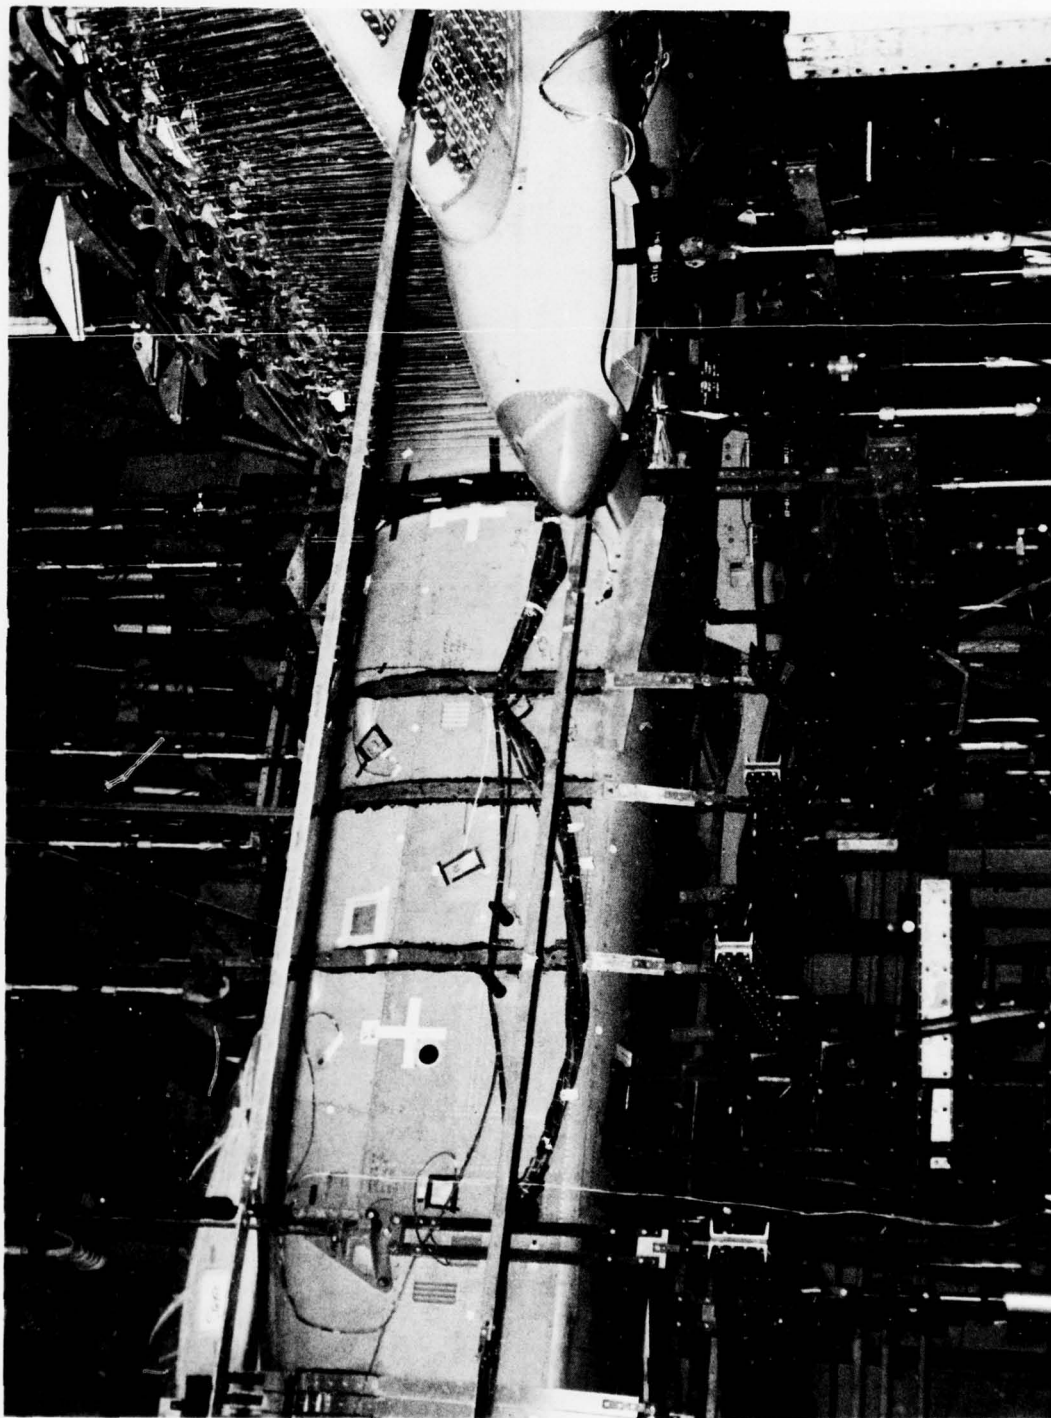
Figure 3. Typical Test Set-up - Wing and Fuselage

load patch, compression pad, or any attachment that was designed to meet a specific problem. The linkage was attached with flexible cable connectors. For flexible cable connection, a special quick-disconnect fitting was used with a selection of several flexible cable lengths. Figures 3 & 4 show typical test set-ups.

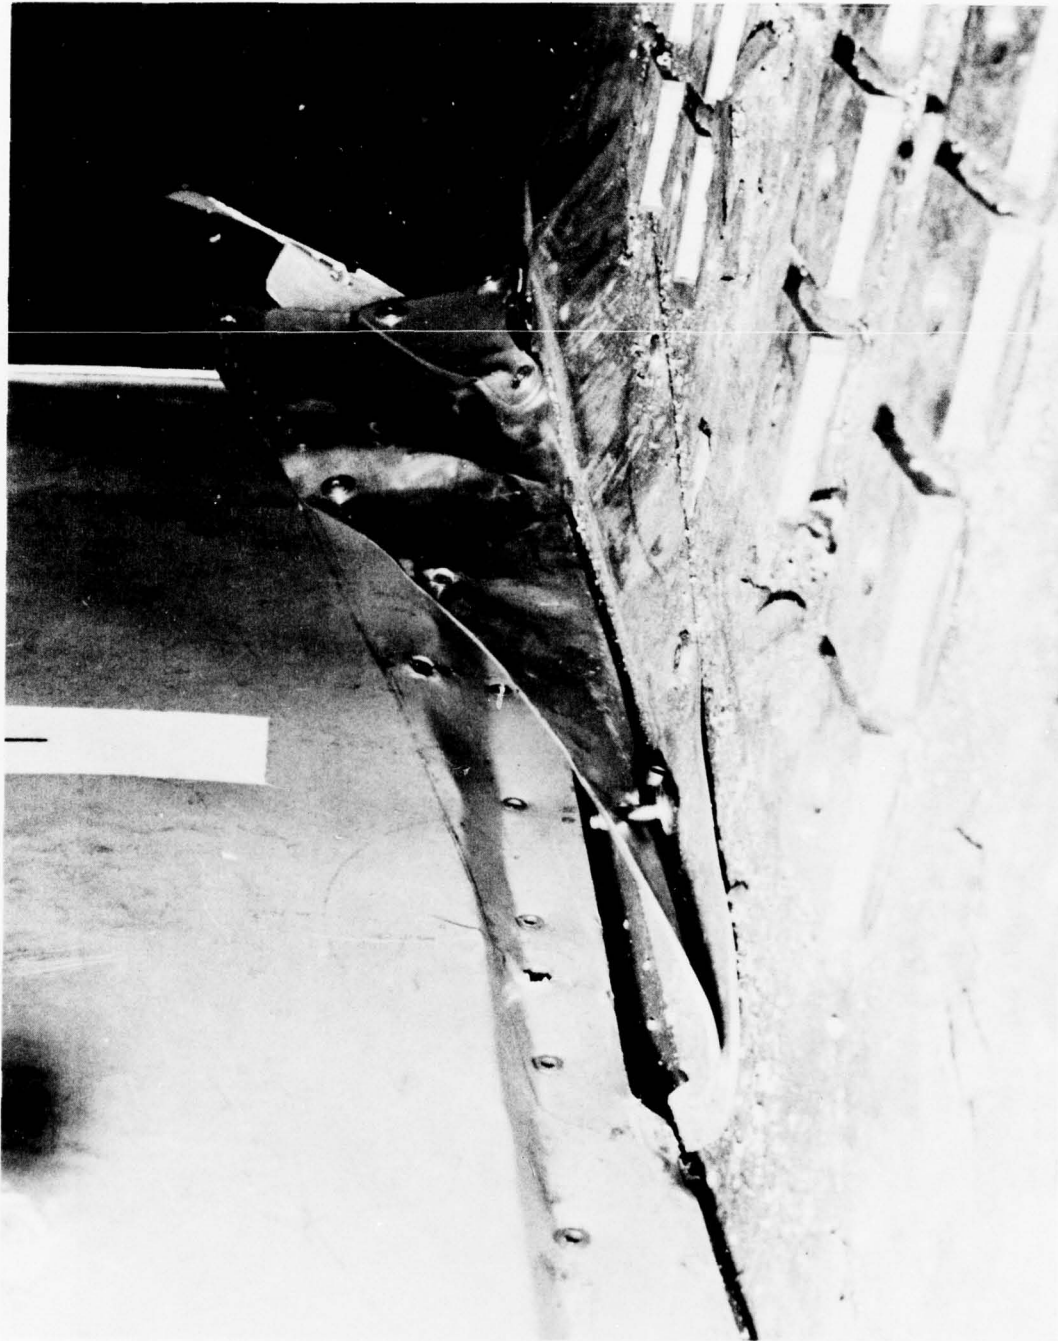
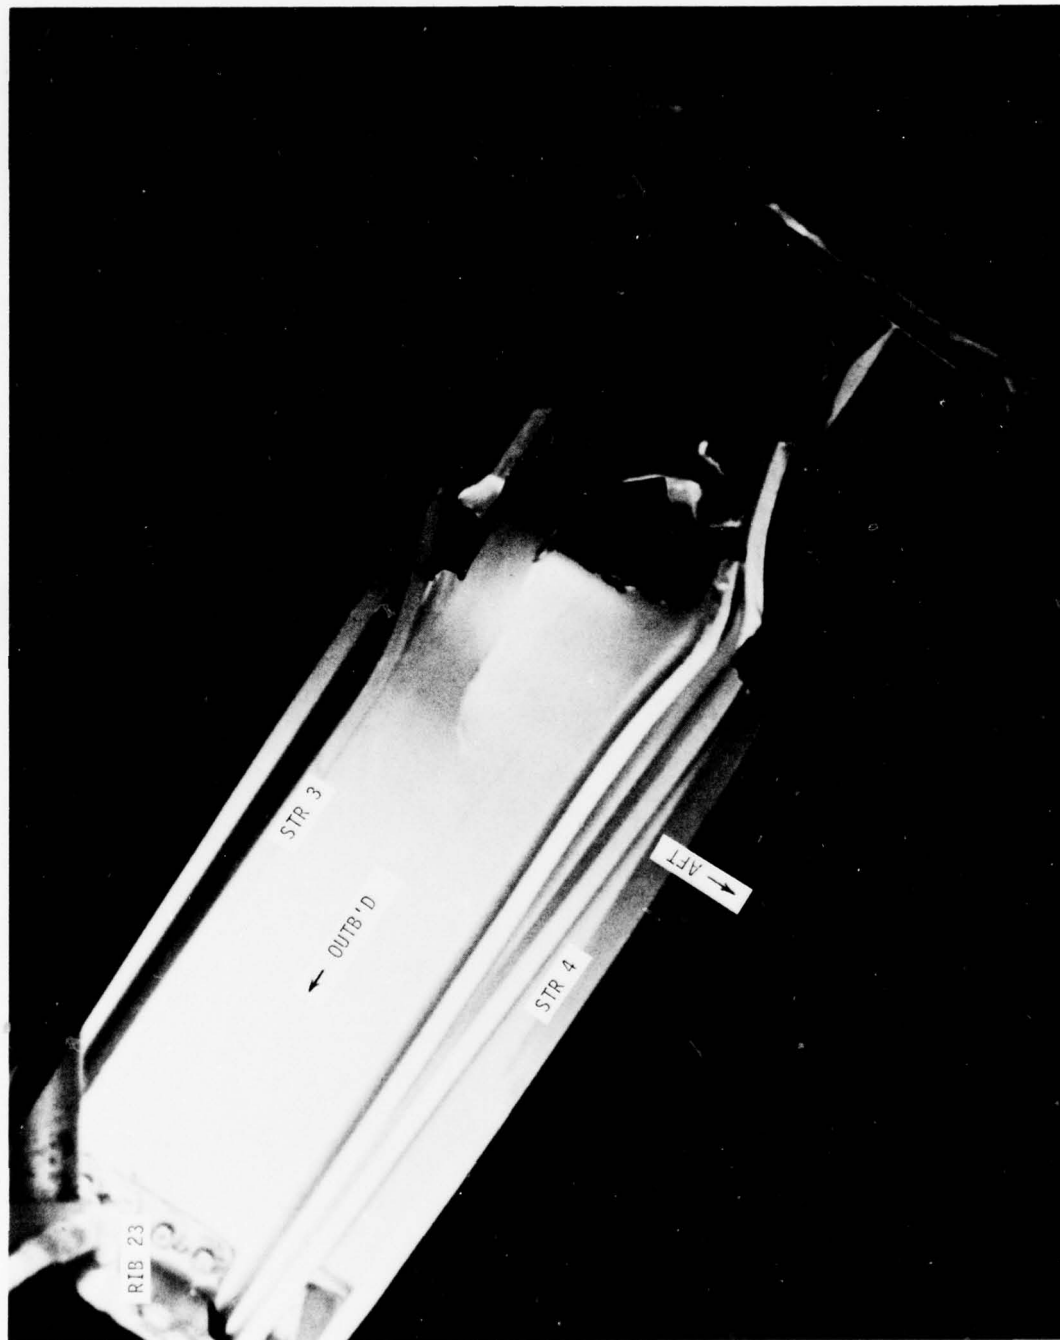
There was a failure in the test hardware at approximately 95% DUL. This condition was repeated as a failing load test (Item 87). The structure supported 127% DUL. At this load, the upper inboard cover of the wing failed between BLO and LBL23. Damage to the structure after the failing load test is shown in Figures 8 through 18.

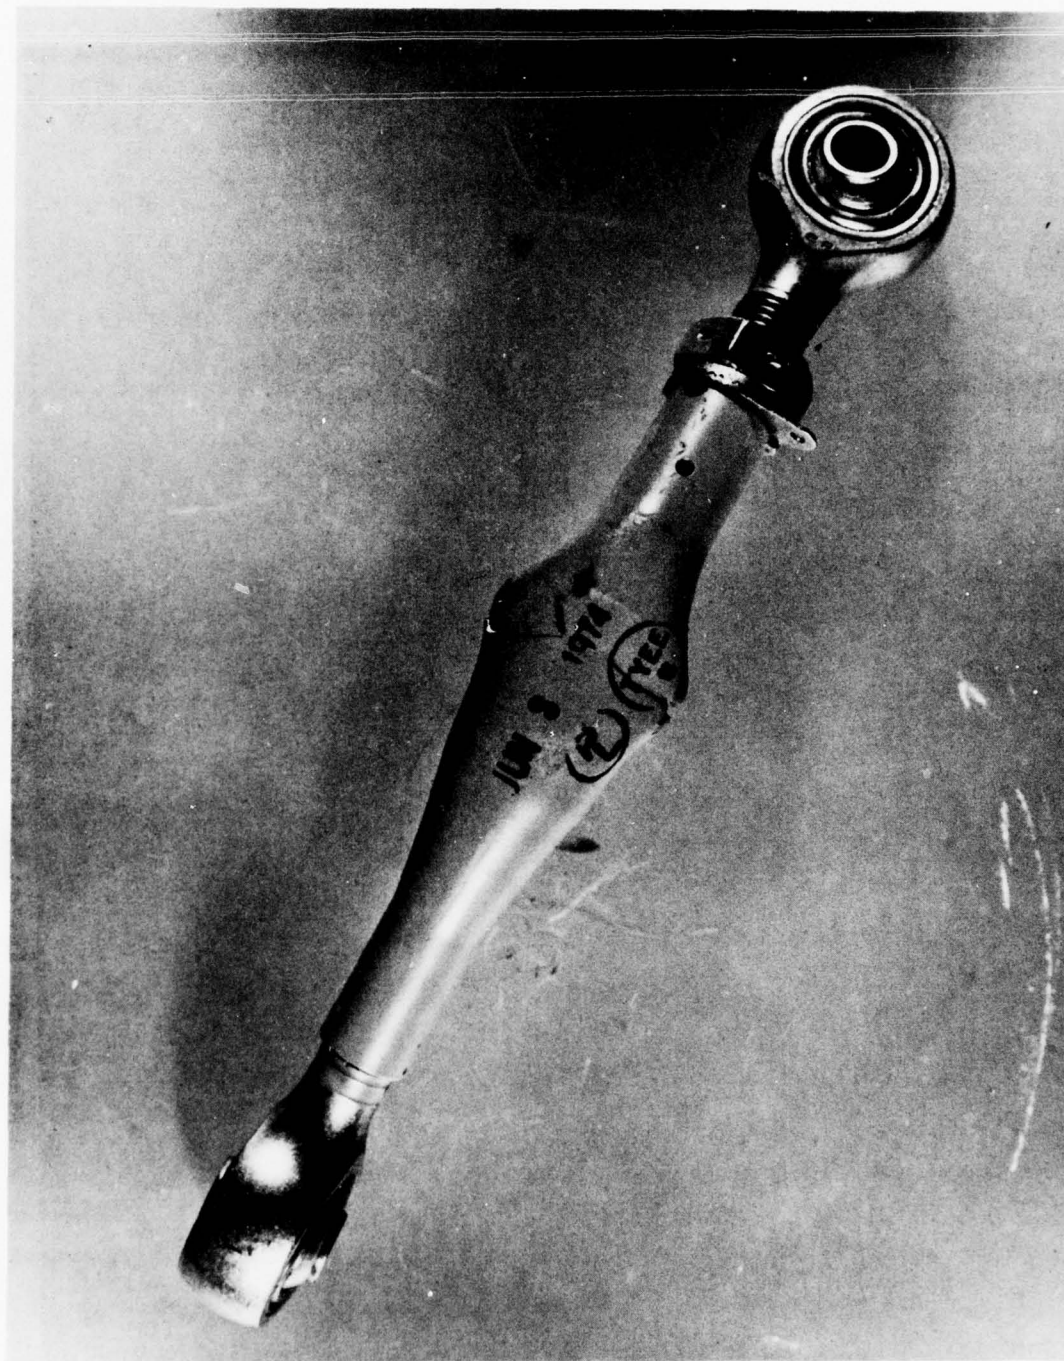
Figure 19. Failed Yaw Output Pushrod - Part No. 160C123005

The Yaw Right Condition (Cond. C-15g) was started with the pedals in the neutral position at no load. At approximately 30% DUL, the right pedal was against the stop. While loading from 67% DUL to 75% DUL, a pushrod (P/N 160C123005) buckled (Fig. 19). It was found that the pushrod had not been adjusted to the correct length when it was installed.

The Yaw Right Condition was repeated using the 005 pushrod from the left side of the system in place of the one that failed. The test was started with the right pedal in the most aft position with no load. The system supported 100% DUL. However, while returning to zero load, the 005 pushrod buckled at approximately 30% DUL. It appeared that the self-aligning rod ends became jammed. This then introduced a bending moment into the pushrod and caused it to fail.

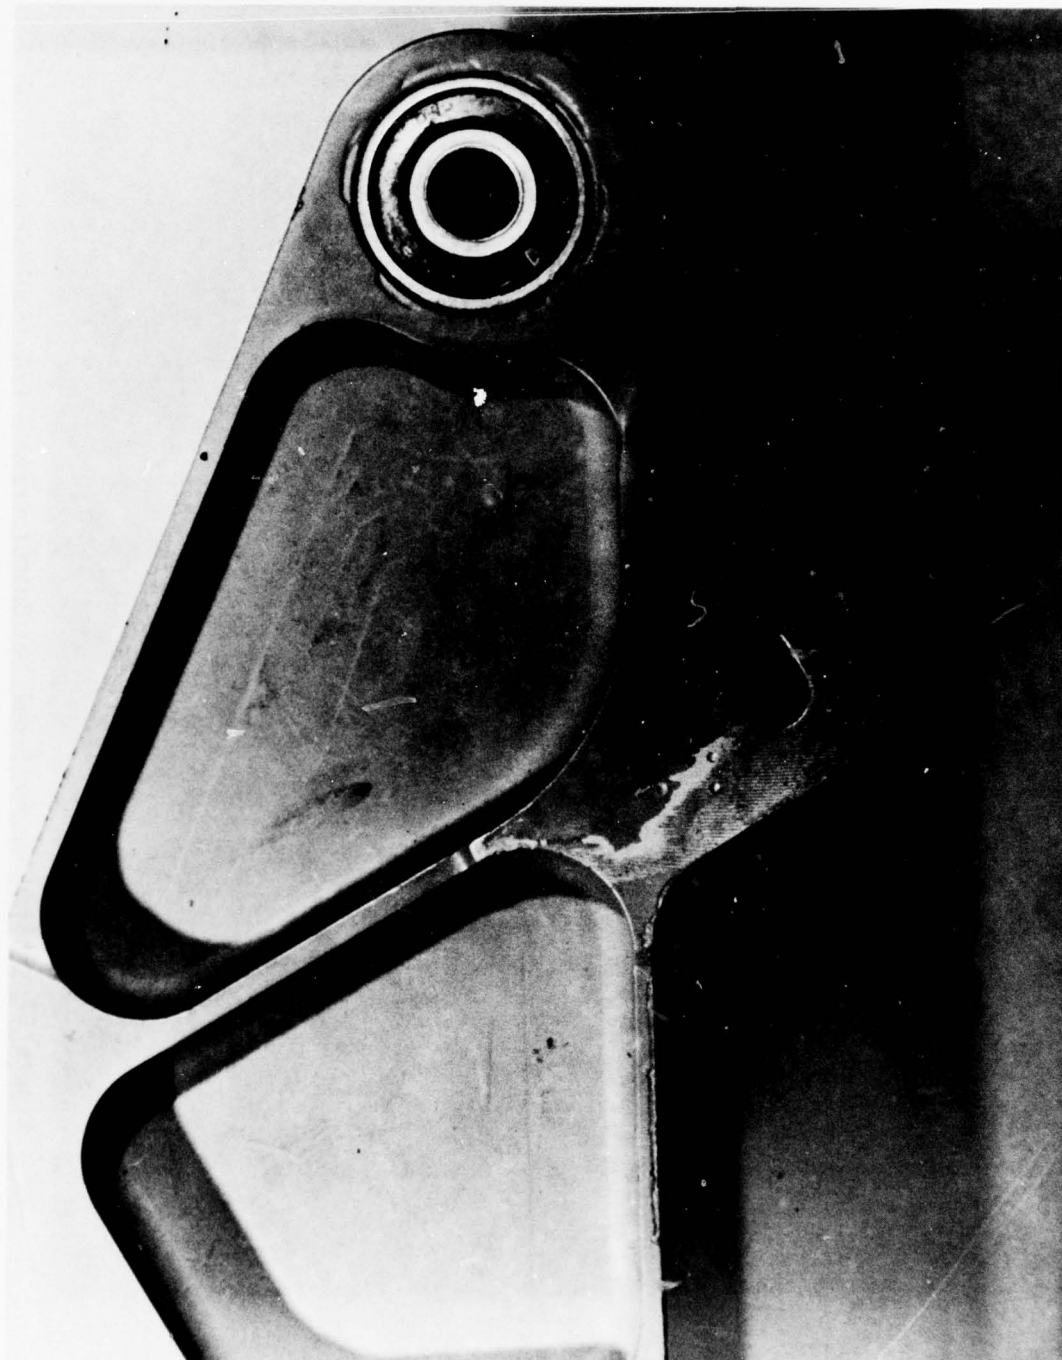
The Yaw Control Subsystem, Manual Reversion Mode Test (C-15h) was started with the bellcrank 1/4" from the stop. The bellcrank was against the stop at approximately 63% DUL. The test was re-started with the bellcrank 1/2" from the stop. While loading from 90% to 95% DUL, the load started to drop. The test was stopped to review the data and inspect the system, no damage was found. The test was re-started. At 60% DUL, the observer in the cockpit reported that the bellcrank appeared to be rolling. The system was inspected and there being no apparent damage, testing was continued. While loading to 90% DUL the applied load started to drop. The test was stopped and inspection of the system showed that the Rudder Pedal Output Yaw Crank (P/N 160D123150) was bent (Fig. 27 and 28). The crank from the left side of the system was removed and installed in place of the damaged crank. The test was repeated and the system supported 100% DUL.

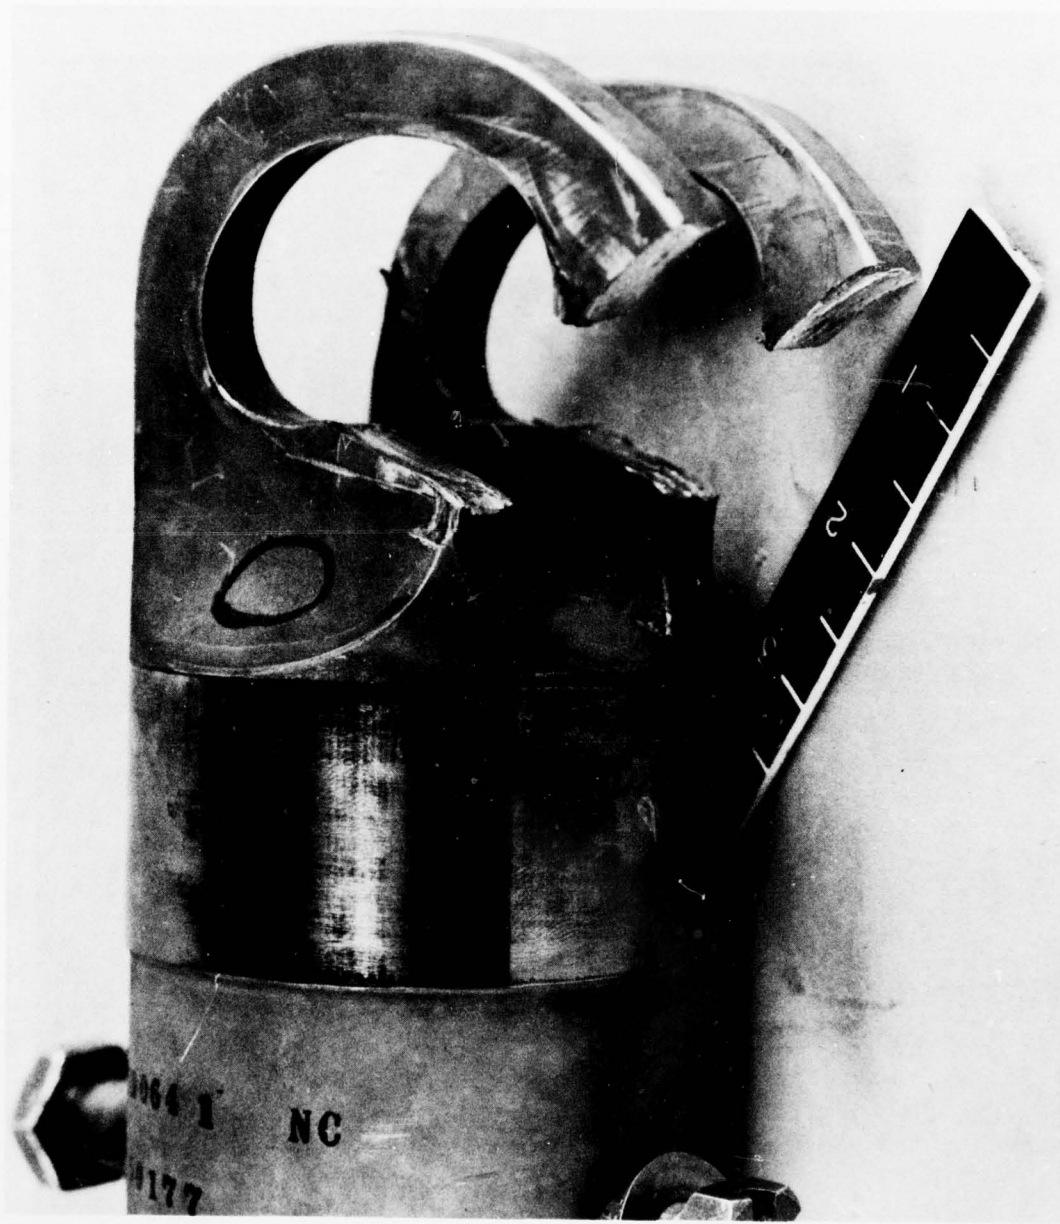
The Main Landing Gear Support Structure Failing Load Test (Two Point Brake Roll Condition) was run to 113% DUL. At this load, the drag strut pickup lugs on the socket pin failed (P/N 19062). The failure and damaged parts are shown in Figures 32 through 36.

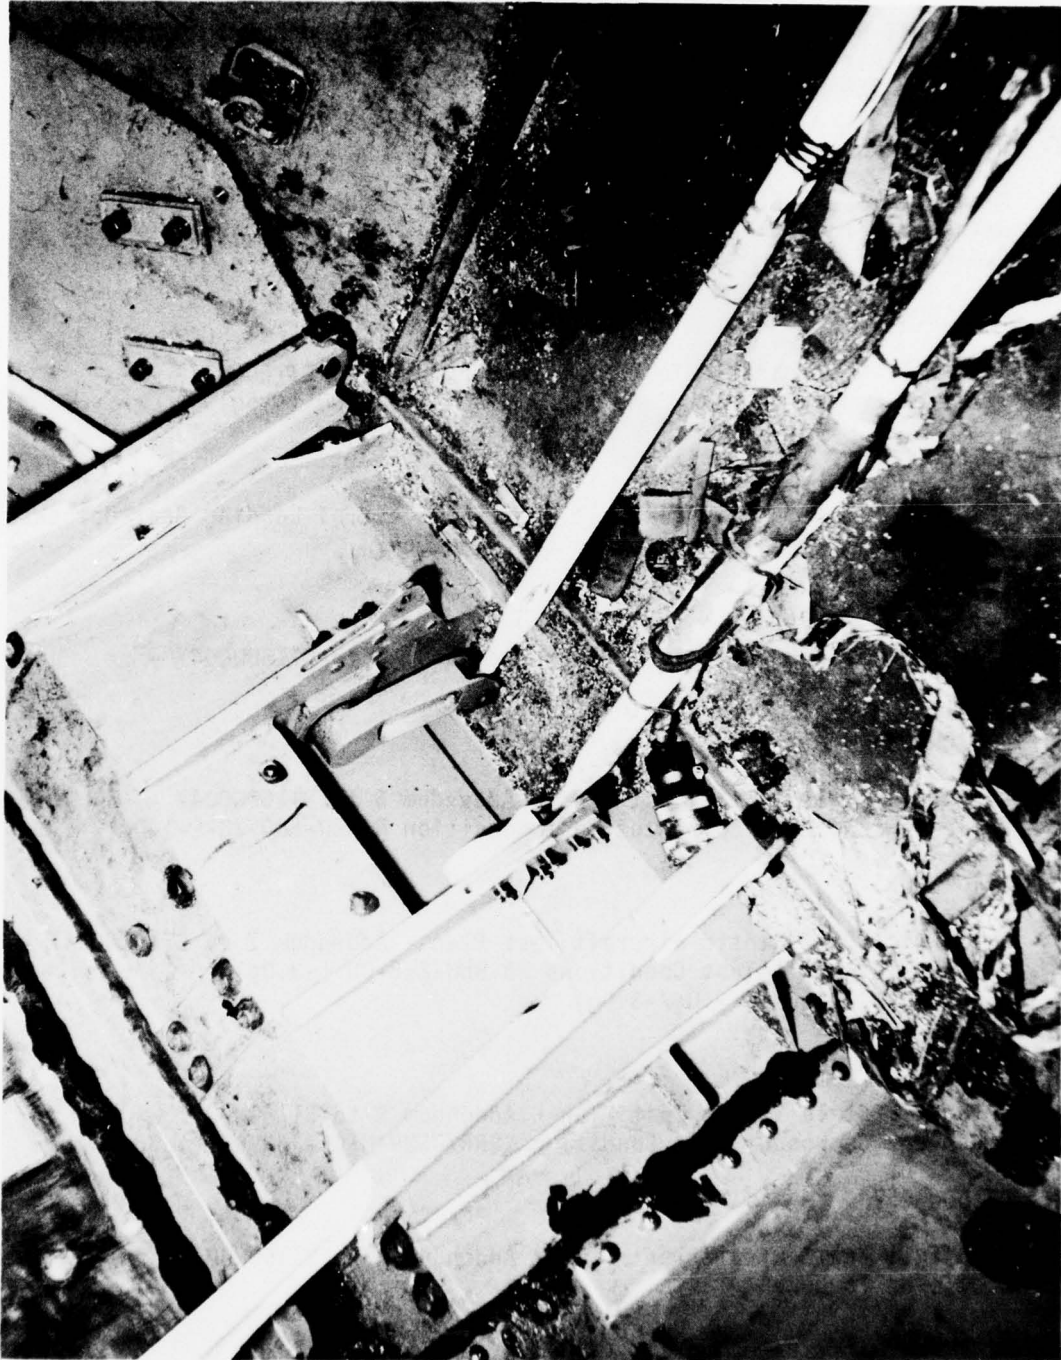
The ACES II HTES Seat Support Structure Test was run to 93% DUL. At this load, the seat rails (P/N 160D188065-1 & -2) and the rail attachment lugs on the seat support casting (P/N 160D116027) failed. The A-10 SPO has determined that this load level is adequate for acceptance of the seat support structure. Therefore, a re-design and re-test of the structure is not necessary. The failure and damaged parts are shown in Figures 37 through 39.
